Research Investigation RI 96-005

October, 2000

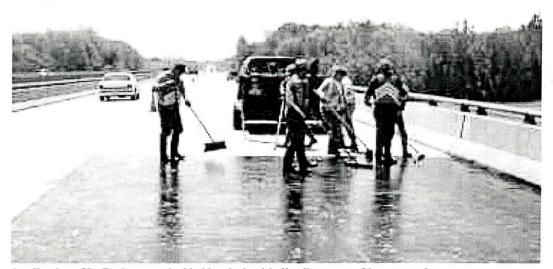
Figure 1

Application of In-Deck on cracked bridge deck with distributor wand brooms and squeegees.

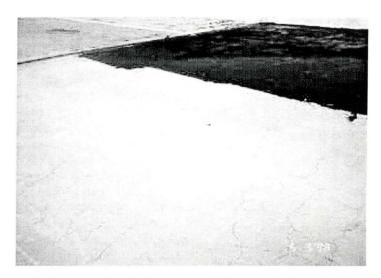
In the foreground is a badly map cracked concrete deck, typical for sealing with Indeck, which is being done in the background

It is recommended that this product be used on more bridge decks with cracking problems. In cases where cracking is severe it is recommended it be used in lieu of polymer modified AC and traprock seal coats. Again, it is strongly recommended that applications be limited to cooler weather in the spring or fall when the cracks will be more open and allow better penetration of the Indeck.
